# NATIONAL TRANSPORTATION SAFETY BOARD

## SAFETY STUDY

### Emergency Evacuation of Commercial Airplanes

**NTSB/SS-00/01  
PB2000-917002  
Notation 7266  
Adopted June 27, 2000**

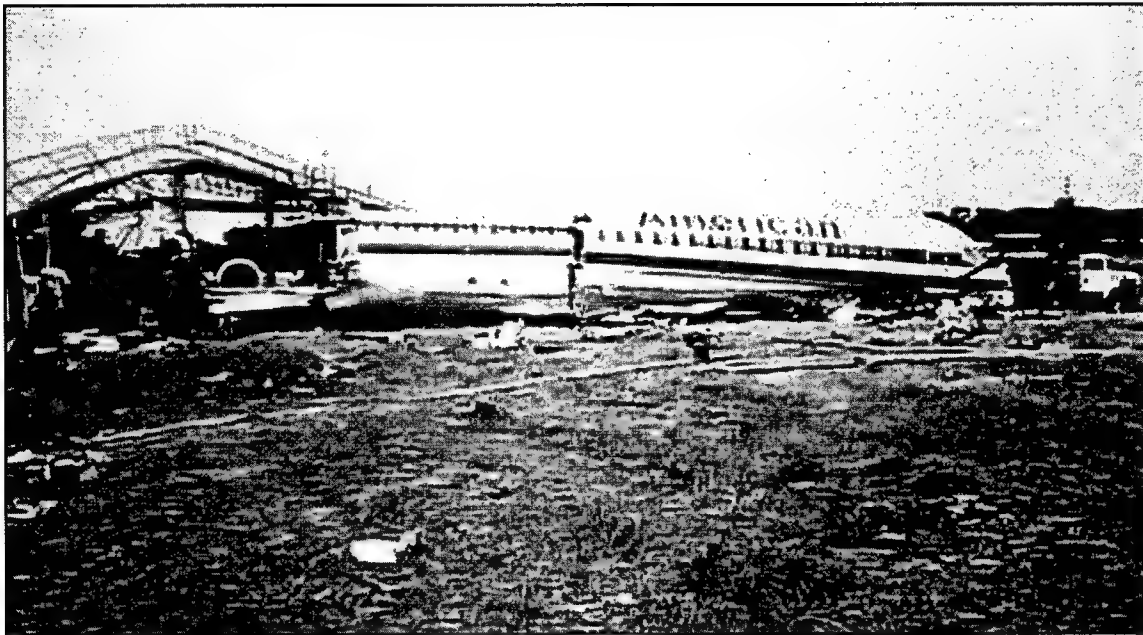
In the MD-82 accident in Little Rock, Arkansas (case 45), the crash forces caused seats to break free from their seat tracks and block aisles. In the forward portion of the cabin, passengers had to navigate around fallen overhead bins and across a severely deformed floor. Fortunately, the crash caused several gaps in the fuselage that passengers were able to use for egress. As seen in figure 5–3, the crash forces split the cabin in two separate sections divided at the wing.

**Figure 5-3.** View of the McDonnell Douglas MD-82 accident scene that involved evacuation on June 1, 1999, Little Rock, Arkansas (case 45).

Based on the circumstances of the evacuation in this accident, the Safety Board recommended that the FAA

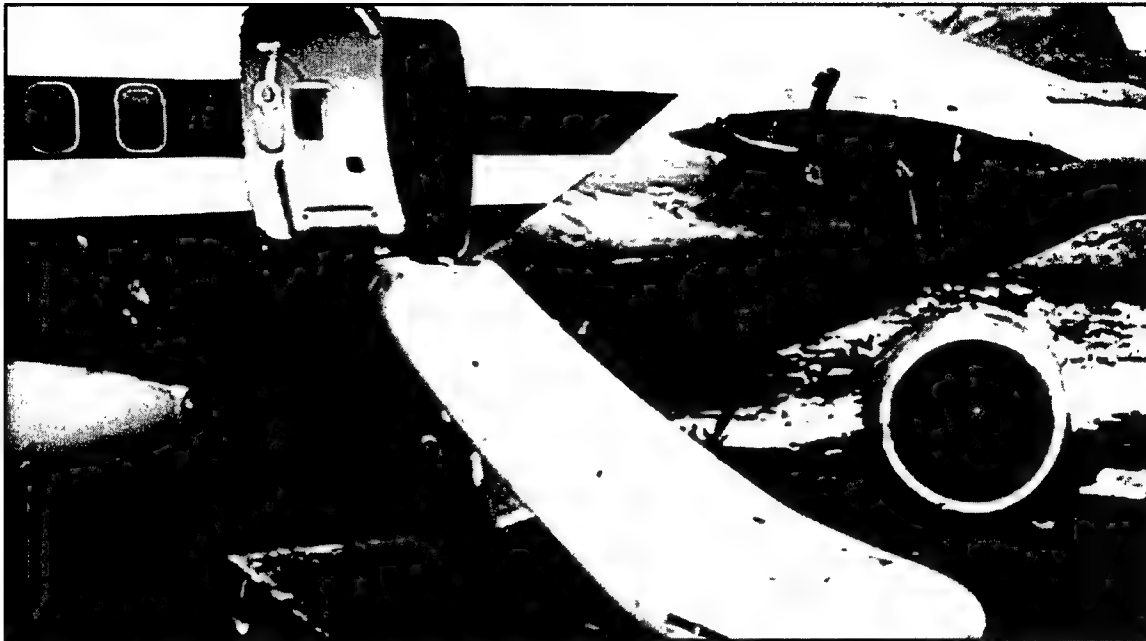
**Figure 5-4.** View of a slide used in the Boeing 727 evacuation on February 9, 1998, Chicago, Illinois (case 9).

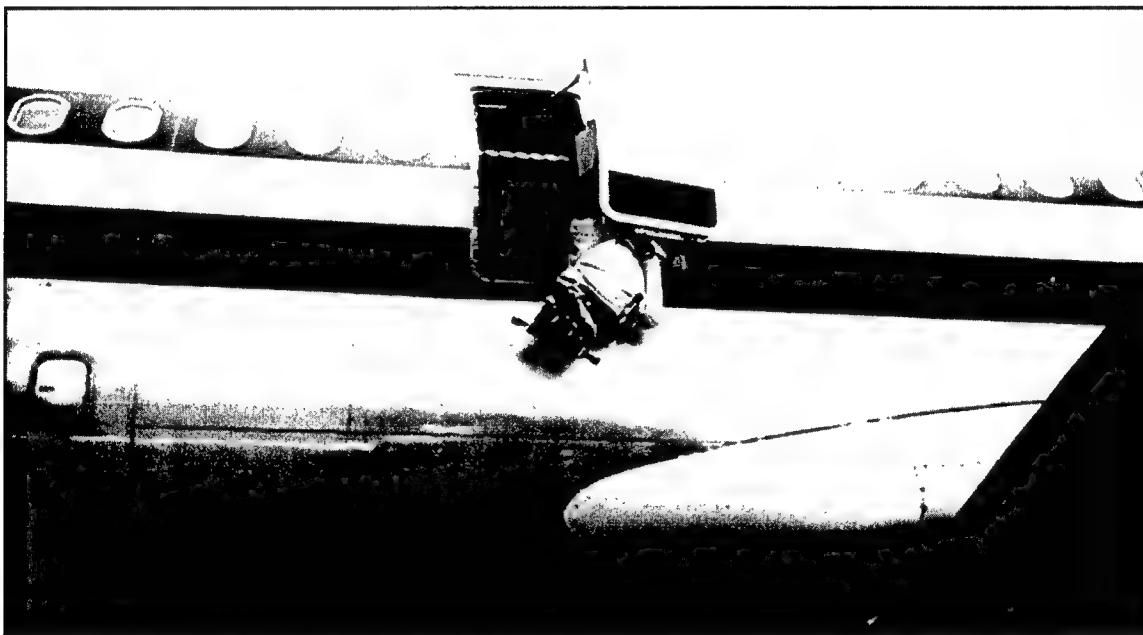
Seven passengers reported that they had difficulty attempting to open an airplane floor level exit door during their evacuation: five were involved in the evacuation of the MD-82 in Little Rock, Arkansas (case 45); one was involved in the evacuation of an A300 in San Juan, Puerto Rico (case 24); and the last was in the evacuation of a 727 in Chicago, Illinois (case 16). Three Little Rock passengers attempted to open a floor level exit door leading to the tailcone; the door exit could not be opened because of a deformation in the floor of the airplane. The two other Little Rock passengers attempted to open inoperable forward floor level exit doors. The 727 passenger reported opening the L2 door 10 inches before it “jammed.” Finally, the A300 passenger attempted to open the R3 door that had not opened as intended after a flight attendant first tried to open the door (figure 5-5).

**Figure 5-5.** View of the R3 door that failed to operate as intended following the Airbus 300 accident on July 9, 1998, in San Juan, Puerto Rico (case 24).

The floor level exit door problems in the MD-82 evacuation were associated with airplane and exit deformation that resulted from the impact sequence. The floor level exit door problem in the A300 case was determined to be the result of the slide pack and will be discussed in the section on evacuation slides. Finally, no determination could be made as to why the floor level exit door on the 727 jammed. In summary, in 43 of the 46 of evacuation cases in the Safety Board’s study, floor level exit doors were opened without difficulty.

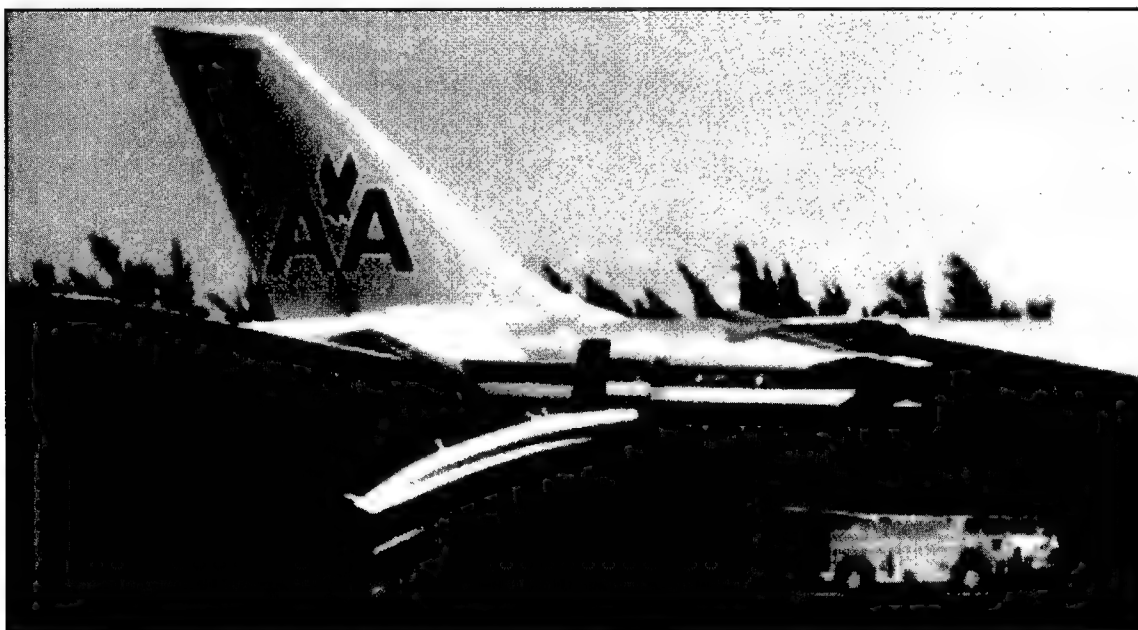
deploy the slides at R1, R2, and R4. However, there was a delay in deploying the R1 slide because of a failure of the power assist in the door. Also, the R3 door partially opened before jamming. The flight attendant tried repeatedly to open the door, but reported that he “knew [the slide] was caught up” in the pack. Postincident testing conducted by the Safety Board indicated that the malfunction might have been caused by a Velcro® fastener that became hooked on a clip on the inside of the decorative cover. In addition, the slide deployed at R4 was unusable for a period of time because winds were blowing the slide against the airplane (figure 5–9). During this time, the 234 passengers were exiting from only two of the eight exits on the A300.

**Figure 5–9.** View of the wind’s effect (25-knot gusts) on the evacuation slide used following the Airbus 300 accident on July 9, 1998, in San Juan, Puerto Rico (case 24). Passengers were able to use this exit after a person on the ground held the slide in place.
